Manhole Inspection Summary

Manhole # S29I__029MH

Insp Date: **9/10/08 8:21 AM**

Location Address: **22 S Green St (Weinberg Building)**

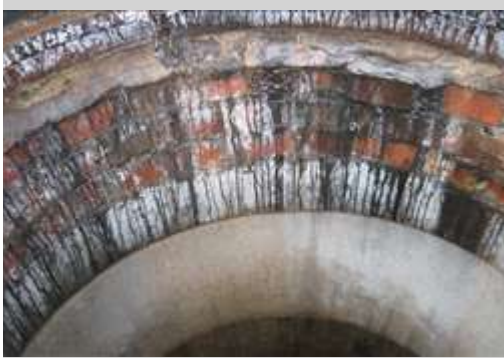
Miscellaneous

Infiltration: ☐ None ☒ **Joint** ☐ Cracks ☐ Mortar ☐ Roots ☐ Wall

signs of infiltration

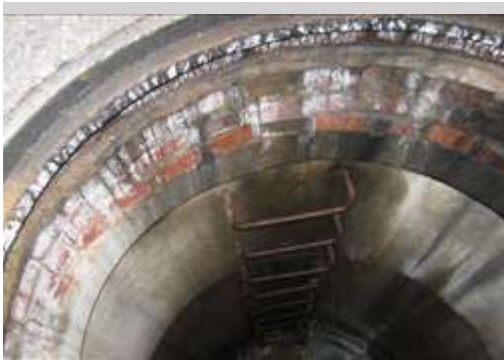
Defect 1

chimney infiltration

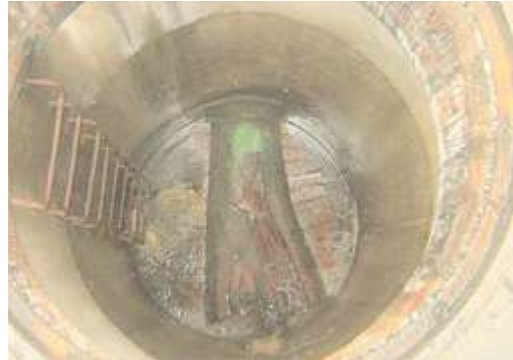
Defect 2

Count: **9** Missing: **0** ☒ **Corroded**

corroded steps

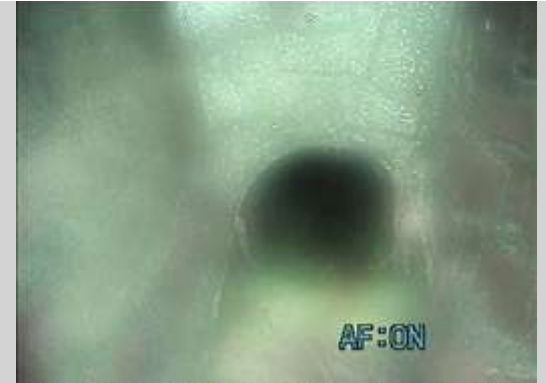
12 O'Clock Outflow

Pipe Height: **10.8** (in.) Rod and Bar (Angled)
Pipe Material: **Clay** ☐ Pipe Lined
Invert Depth: **12.97** (ft.) Flow Characteristics: **Fast**
Deposits: ☒ None ☐ Mud ☐ Sludge ☐ Debris ☐ Grease
Silt Depth: **0** (in.) Deposits Extent:
Infiltration: **None** Pipe Seal Cond: **Sound**

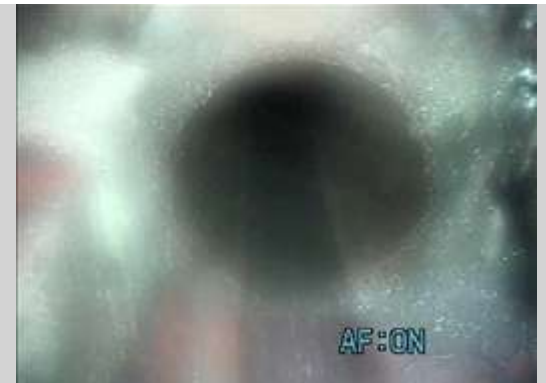
5 O'Clock Inflow

Pipe Height: **10.8** (in.) Rod and Bar (Angled)
Pipe Material: **Clay** ☐ Pipe Lined
Invert Depth: **11.79** (ft.) Flow Characteristics: **Fast**
Deposits: ☒ None ☐ Mud ☐ Sludge ☐ Debris ☐ Grease
Silt Depth: **0** (in.) Deposits Extent:
Infiltration: **None** Pipe Seal Cond: **Sound**

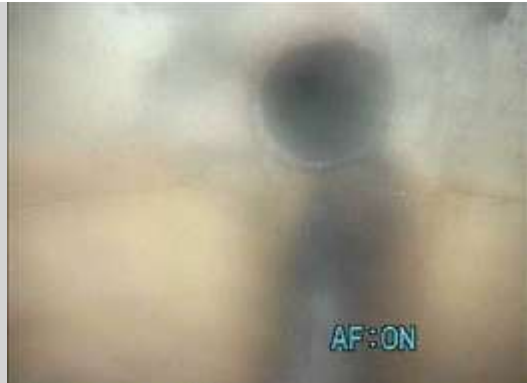
7 O'Clock Inflow

Pipe Height: **7.2** (in.) Rod and Bar (Angled)

Drop: **Inside**

Drop Condition: **Open**
